Upgrade Cisco IOS on an Autonomous Access Point

Document ID: 107911

This document shows how to upgrade a Cisco IOS® image on an autonomous access point through the GUI or CLI.

The information in this document is based on Cisco Aironet 1240AG Series Access Point that runs Cisco IOS Software Release 12.3(8)JEA.

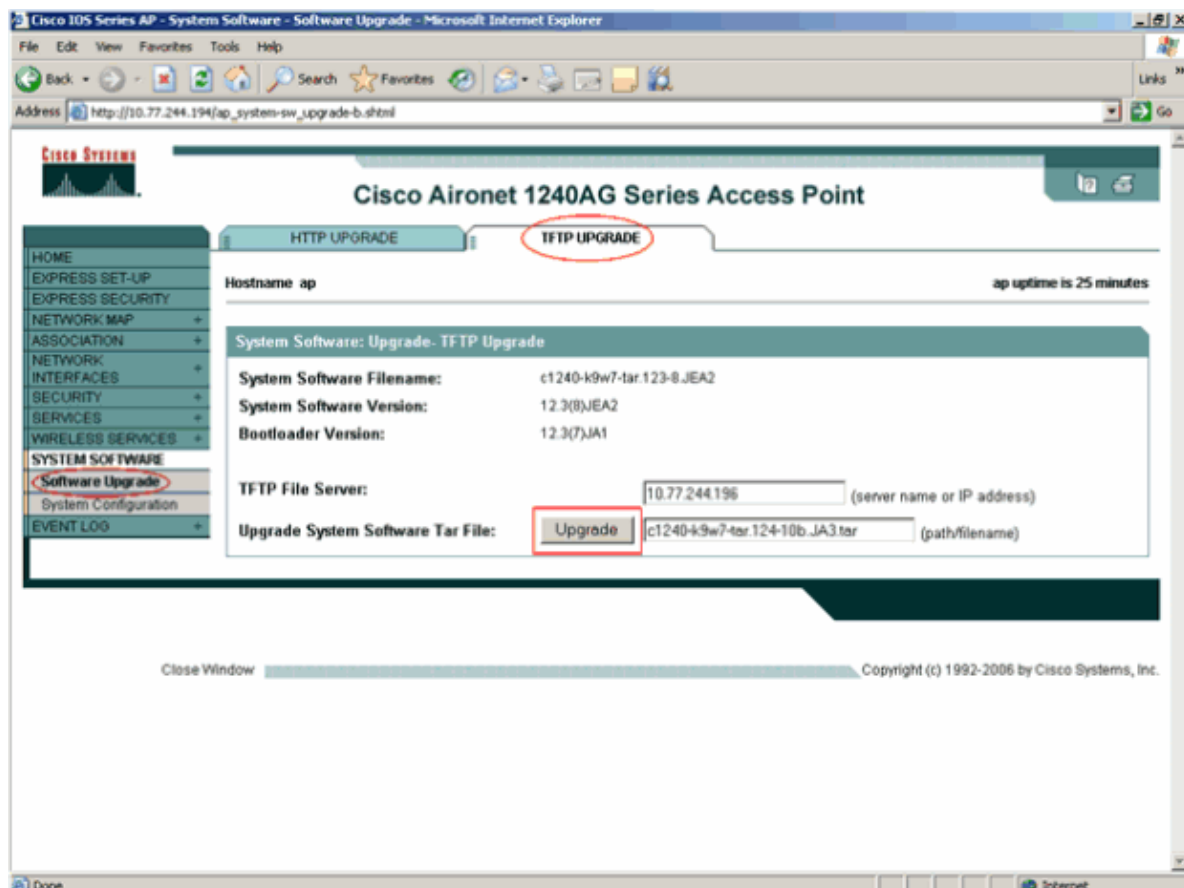
Figure 1

1. Check the current software version of the AP. Open a browser and type `http://<ip address of the ap>` in the address bar in order to log into the GUI. On the main page, click on the **System Software** menu from the left hand side. Choose the **Software Upgrade** option and check the current Cisco IOS version from the **System Software Version** field.
2. From the software upgrade page, choose TFTP upgrade, as shown in Figure 1.

3. Enter the IP address of the TFTP server.
4. Specify the name of the Cisco IOS software file to be upgraded in the **Upgrade System Software Tar file** field, as shown in Figure 1.

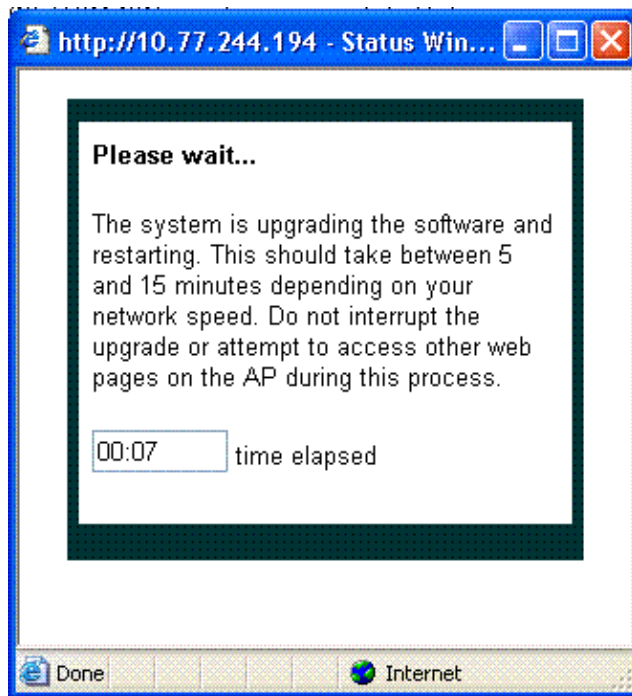
5. Click the **Upgrade** button. A status window similar to the one shown in Figure 2 appears.

This takes few minutes, and then the AP reboots once the upgrade is complete.
